REPUBLIC OF THE PHILIPPINES
MARITIME INDUSTRY AUTHORITY

**MARINE SAFETY INVESTIGATION ON THE
SWAMPING AND SINKING OF LCT "PACIFICA
1" OWNED AND OPERATED BOOMETRIX
DEVELOPMENT CORPORATION**

DATE AND TIME OF ACCIDENT: 0640H of 10 February 2023

**IMO ACCIDENT CLASIFICATION: VERY SERIOUS MARINE
CASUALTY**

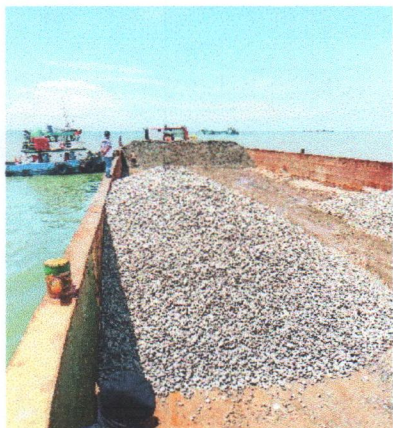
Figure 2 loading of aggregates at Cabinet Cabadbaran loading port by LCT "PACIFICA 2", the other vessel of Boometrix Devpt. Corp.

28. Moreover, the aft section of the cargo deck was left void (approximately 3 meters) as a buffer space between the super structure and cargoes of gravel (as shown by example in Figure No. 2). Based on interview, it was divulged that a homogenous load of sand and aggregates were alternately loaded onboard compromising a total of 50 dump trucks;

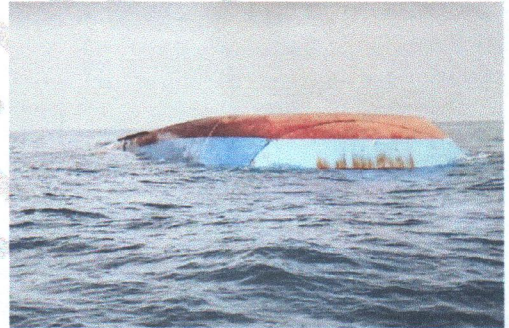
42. On or about 0640H of 10 February 2023, while onboard the liferafts the crew observed that LCT "PACIFICA 1" immediately capsized to port with her bottom hull exposed to the water surface at GPS position LAT 09°48.541N LONG 125°47.90 E (as shown in Figure No. 3);

Figure 3 Overturned and capsized LCT "PACIFICA 1"

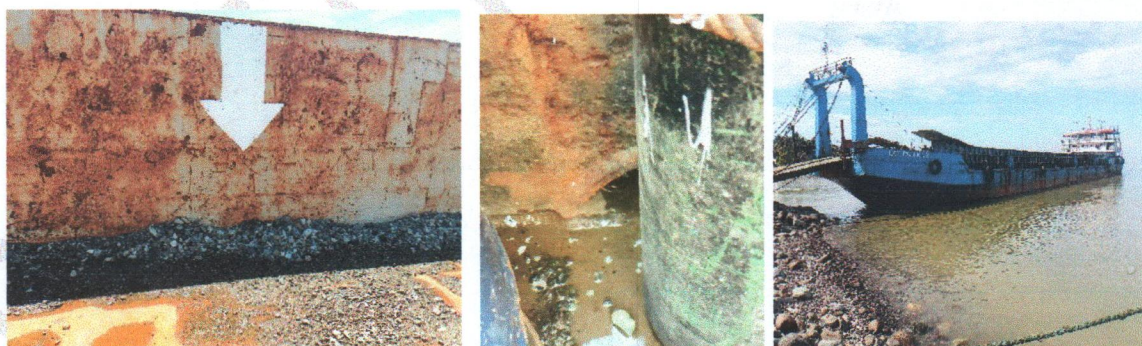
4. It was also observed that the crew failed to ensure that drain pipes and freeing ports (P/S) located on the both the forward and aft section of the cargo deck were free from debris and accumulated sand and gravels. Initial assessment indicates that seawater was trapped on the cargo deck (as shown under figure no. 4 under similar vessel LCT "PACIFICA 2" owned by BOOMETRIX DEVELOPMENT CORP.);

Figure 4 Freeing ports and drain pipes onboard LCT PACIFICA 2 were also obstructed by sand and gravel and other debris

52. Subsequently, there was a large probability that some of the loaded cargo of gravel and sand had blocked the vessel's drain pipes and freeing ports, preventing the egress of water;

1. To immediately adopt and implement in the Safety Management System (SMS) Manual the cargo trimming procedures for solid cargoes in bulk, taking into consideration the cargo characteristics, stowage factor, angle of repose, and special properties of the cargoes in bulk;
2. To conduct additional fleet safety and navigational audits of their remaining vessels;
3. To ensure that drain pipes, freeing ports, and scuppers¹³ are free of obstructions and accumulated debris during voyages;
4. To ensure the monitoring of weather condition and wave condition prior and during the voyage; and
5. To ensure the monitoring of cargo loading operation, and effective communication between the terminal and ship are maintained at all times, especially during the final trimming of the ship.

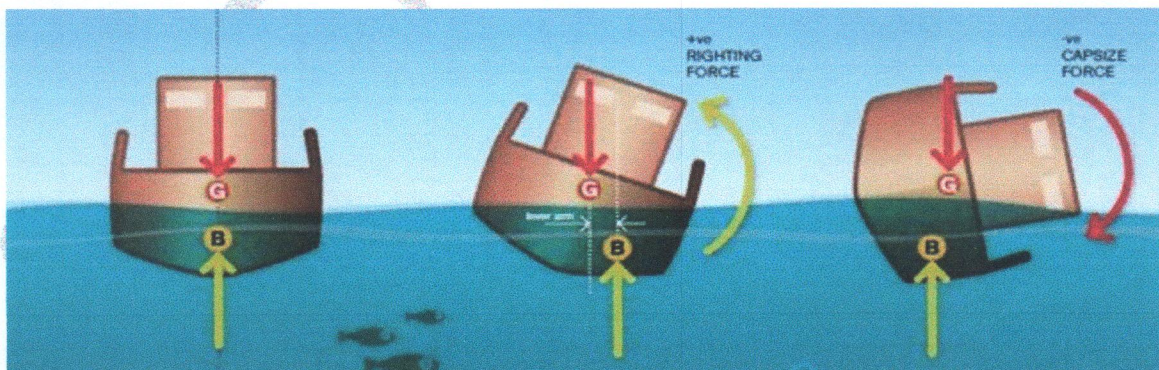
53. With the sloshing of the seawater on deck and continuous rolling of the vessel, large portions of solid bulk cargoes stowed on deck had begun to shift towards the portside of the vessel increasing her list up to 20°;

54. Consequently, the shifting of cargo on deck will definitely cause a list, if the cargo does not return to its original position with subsequent vessel movement. This means that the righting lever for angles of heel will also be reduced, preventing the vessel to regain her upright position;

Figure 5 capsizing sequence

55. Moreover, once the angle of deck edge immersion has been reached, the vessel's stability would also start to diminish, prompting LCT "PACIFICA 1" to list further up to 30° to port and eventually capsized;
56. Finally, an underlying factor that was neglected by the Master is the significance of loads induced by fuel and the amount of ballast water during the voyage that had an effect on the weight distribution along the ship length when LCT "PACIFICA 1" was subjected to rolling and pitching moment;
